Traffic Data Analysis

Harbourview Drive
Eastbound and Westbound

Town of Midland
Engineering Department

September 17, 2021

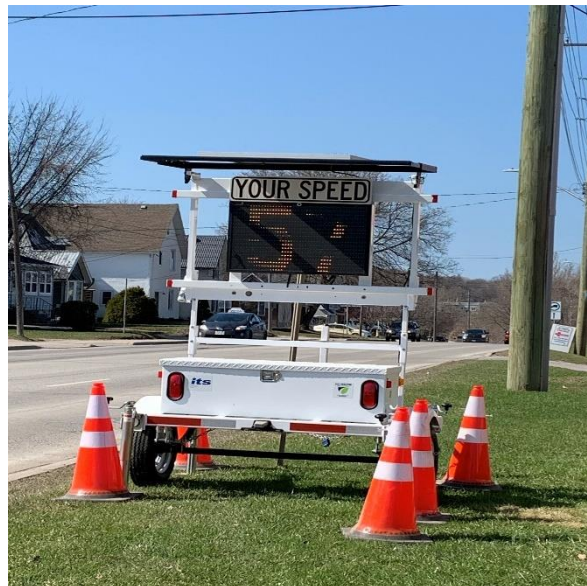
Figure 1- Traffic Trailer

The traffic trailer used was model ATS-3 as shown in Figure 1. The traffic trailer is set to not show the speed as the display was turned off for the duration of this location. The data is collected and grouped into one-hour intervals.

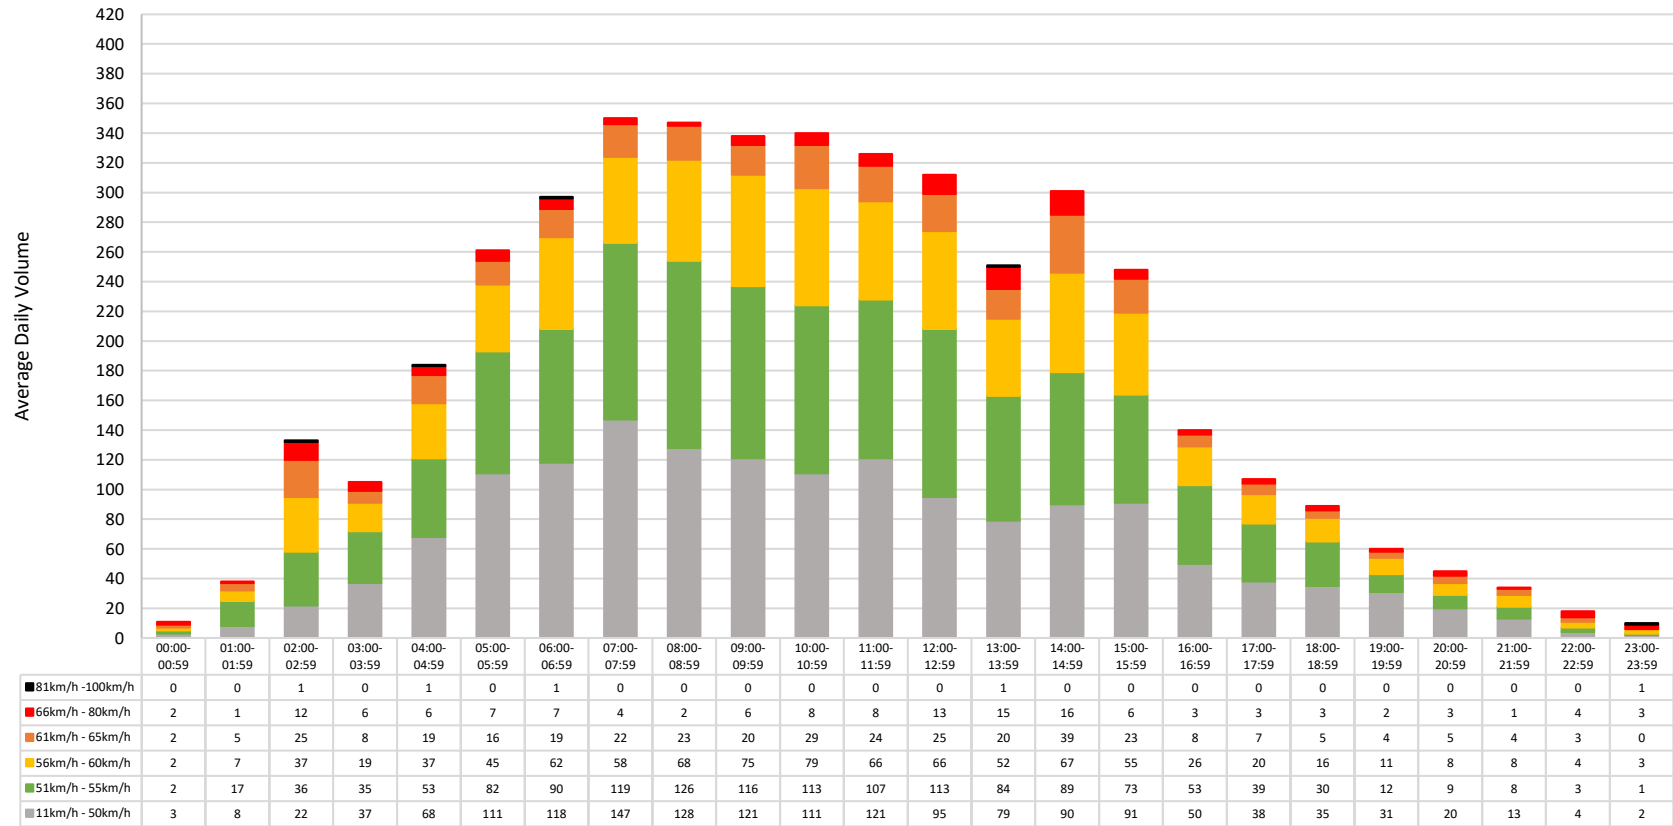
Figure 4 Speed by Hour Analysis for Eastbound Weekends

Figure 4 above is the speed by hour graph used to determine the time where most speeding occurs on the weekend. The data shows that speeding was low at night and began to increase around 5:00 am before beginning to decline again at 3:00pm. The speeding reached a peak from 7:00am until 10:00am.

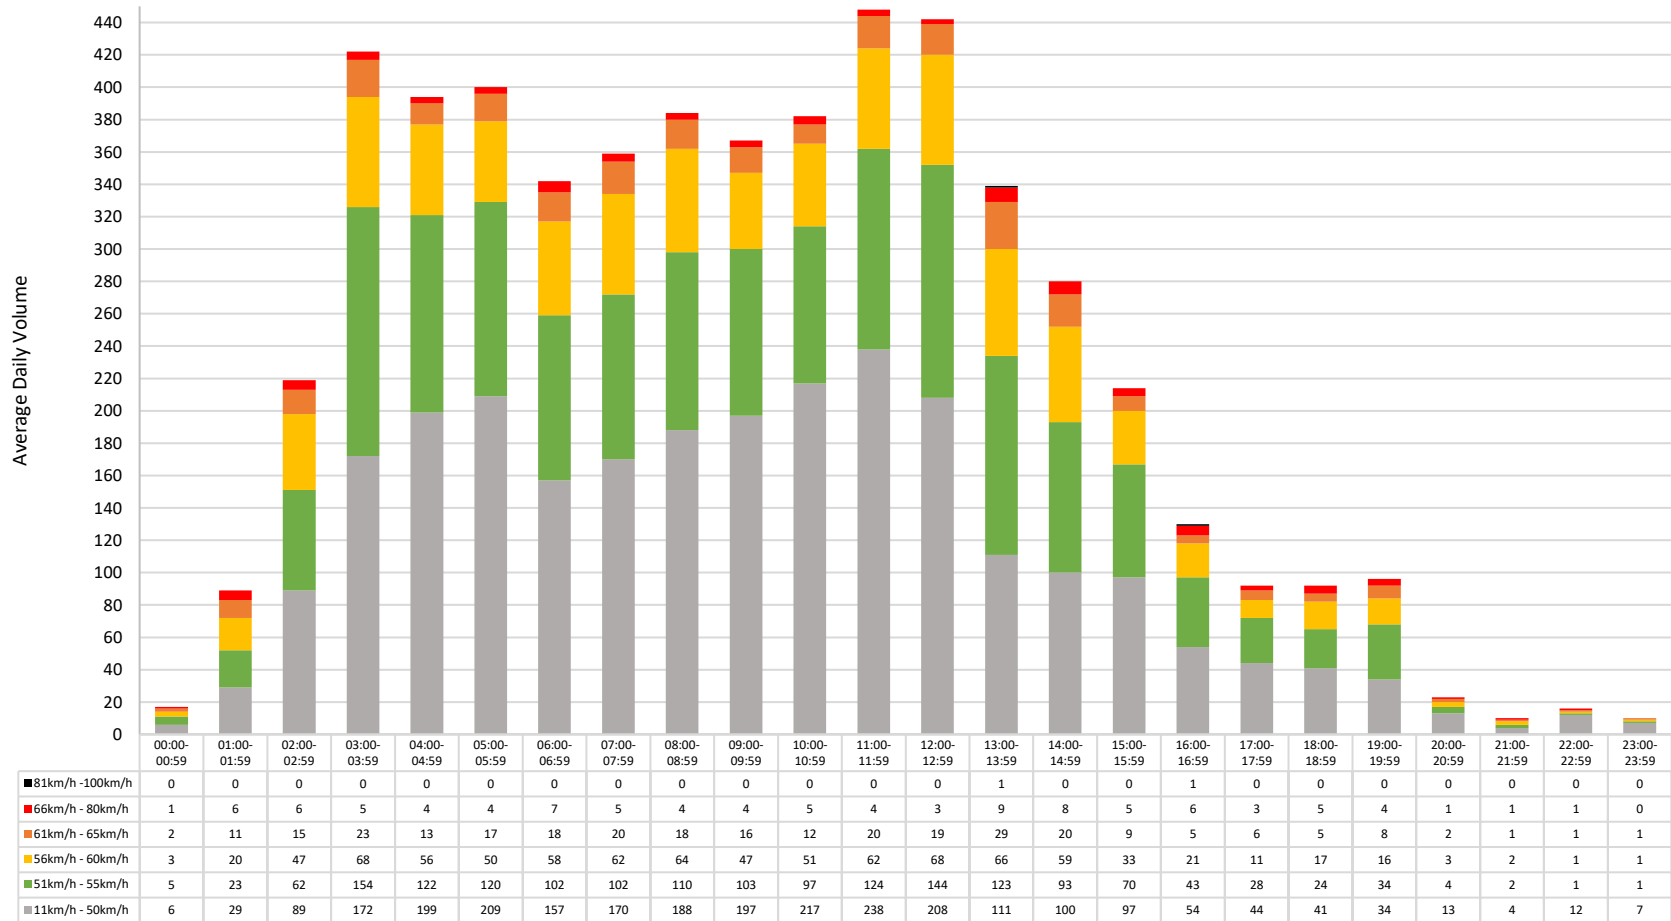
Figure 6- Speed by Hour Analysis for Westbound Weekdays

Figure 6 above is the speed by hour graph used to determine the time where most speeding occurs on weekdays. The data shows that speeding increased throughout the day until it reached its peak from 11:00am to 12:00pm and begins to decline again. There is an additional spike in speeding from 3:00am until 6:00am.

Figure 6 (weekday) and Figure 7 (weekend) above are the speed by hour graphs used to determine the time where most speeding occurs. The data shows that speeding was relatively consistent in the westbound and eastbound direction on weekdays and weekends having spikes from 6:00am to 10:00am.

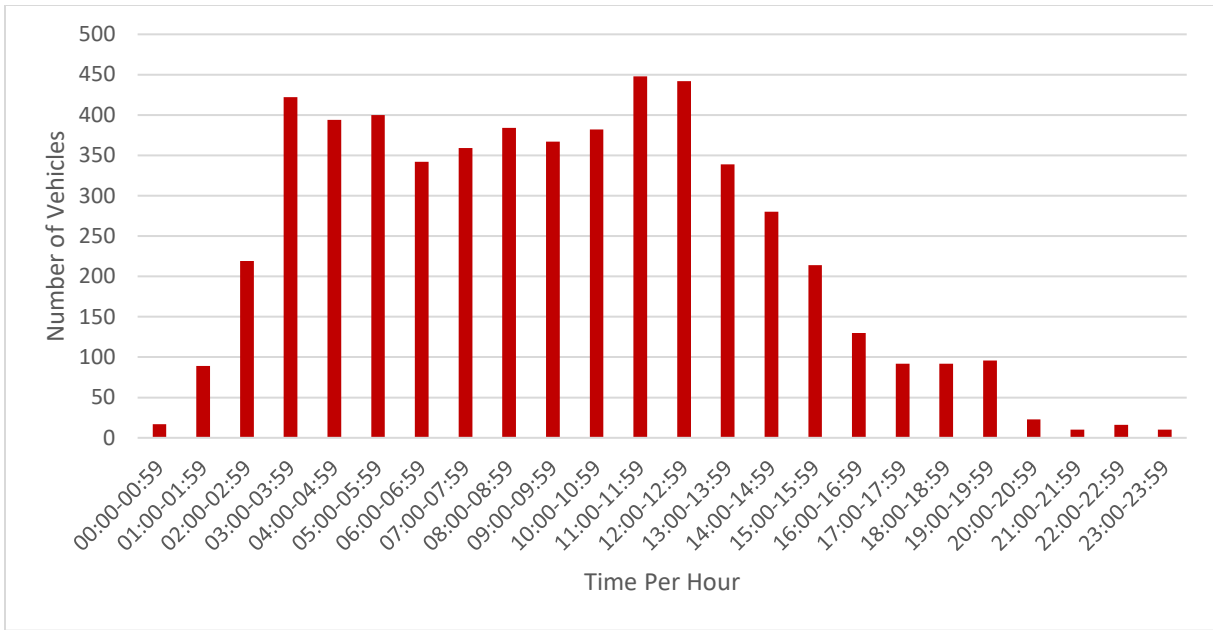
Figure 12- Average Volume by Hour from September 16th, 17th, 20th, 21st and 22nd (Westbound)

As shown in Figure 12, peak traffic occurs in the morning from 5:00am to 12:00am on the weekday in the westbound direction and there was a spike at 3:00am. On the weekend shown in Figure 13 a similar pattern was shown, there was a spike from 7:00am.

The data collected from September 16th, 17th, 20th, 21st and 22nd (weekdays) and September 18th and 19th (weekend) are used to analyze the average traffic volume at different times of the day as shown in Figure 12 and Figure 13, respectively.
