# Traffic Data Analysis

Hugel Avenue

Eastbound and Westbound

Town of Midland

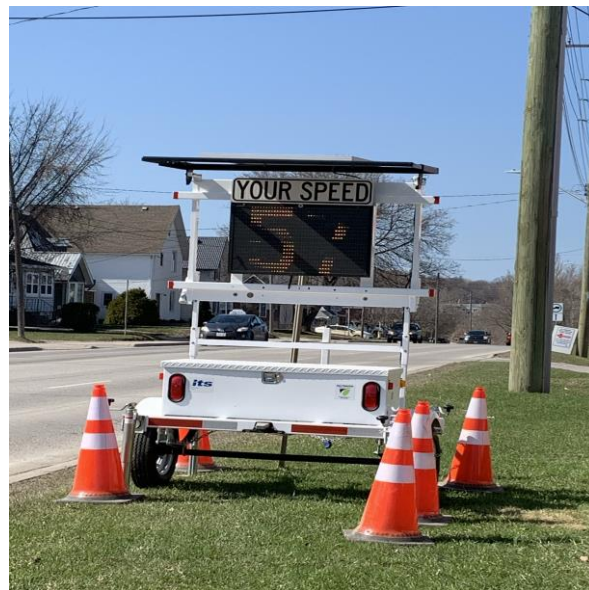
**Figure 1- Traffic Trailer**

The traffic trailer used was model ATS-3 as shown in Figure 1. The traffic trailer is set to show the speed of the approaching vehicle and display short messages depending on the speed. The data is collected and grouped into one-hour intervals.

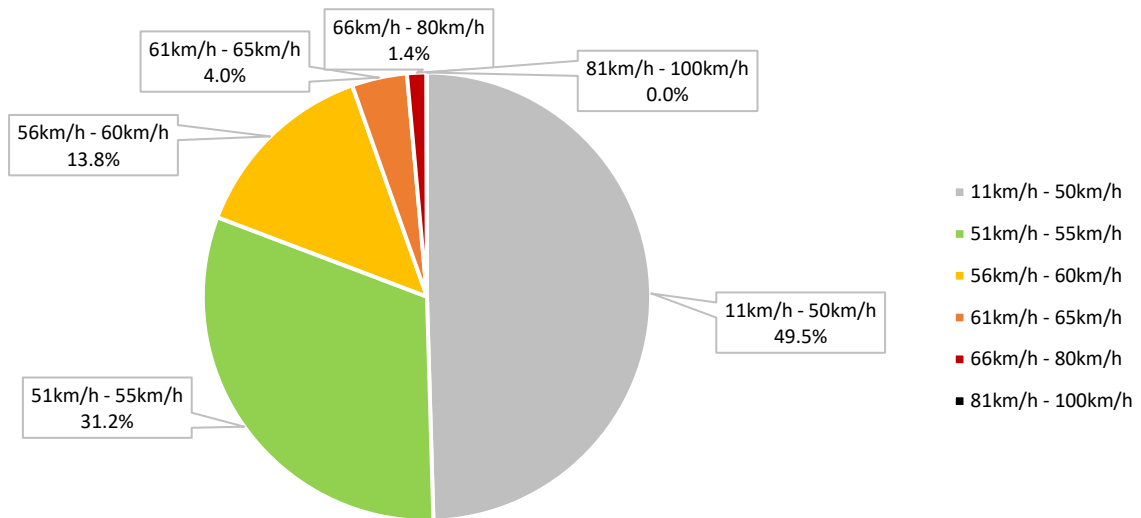
Figure 2- Hugel Avenue Eastbound

Figure 2 above shows that 49.5% of vehicles were travelling below the posted speed limit, 45.0% of vehicles were travelling between 51-60 km/h, and 5.4% of vehicles were travelling above 60km/h. Considering the accepted speed limit is 10km/h over the posted speed limit, a total of 94.5% of vehicles were travelling within the accepted speed limit in the eastbound direction.

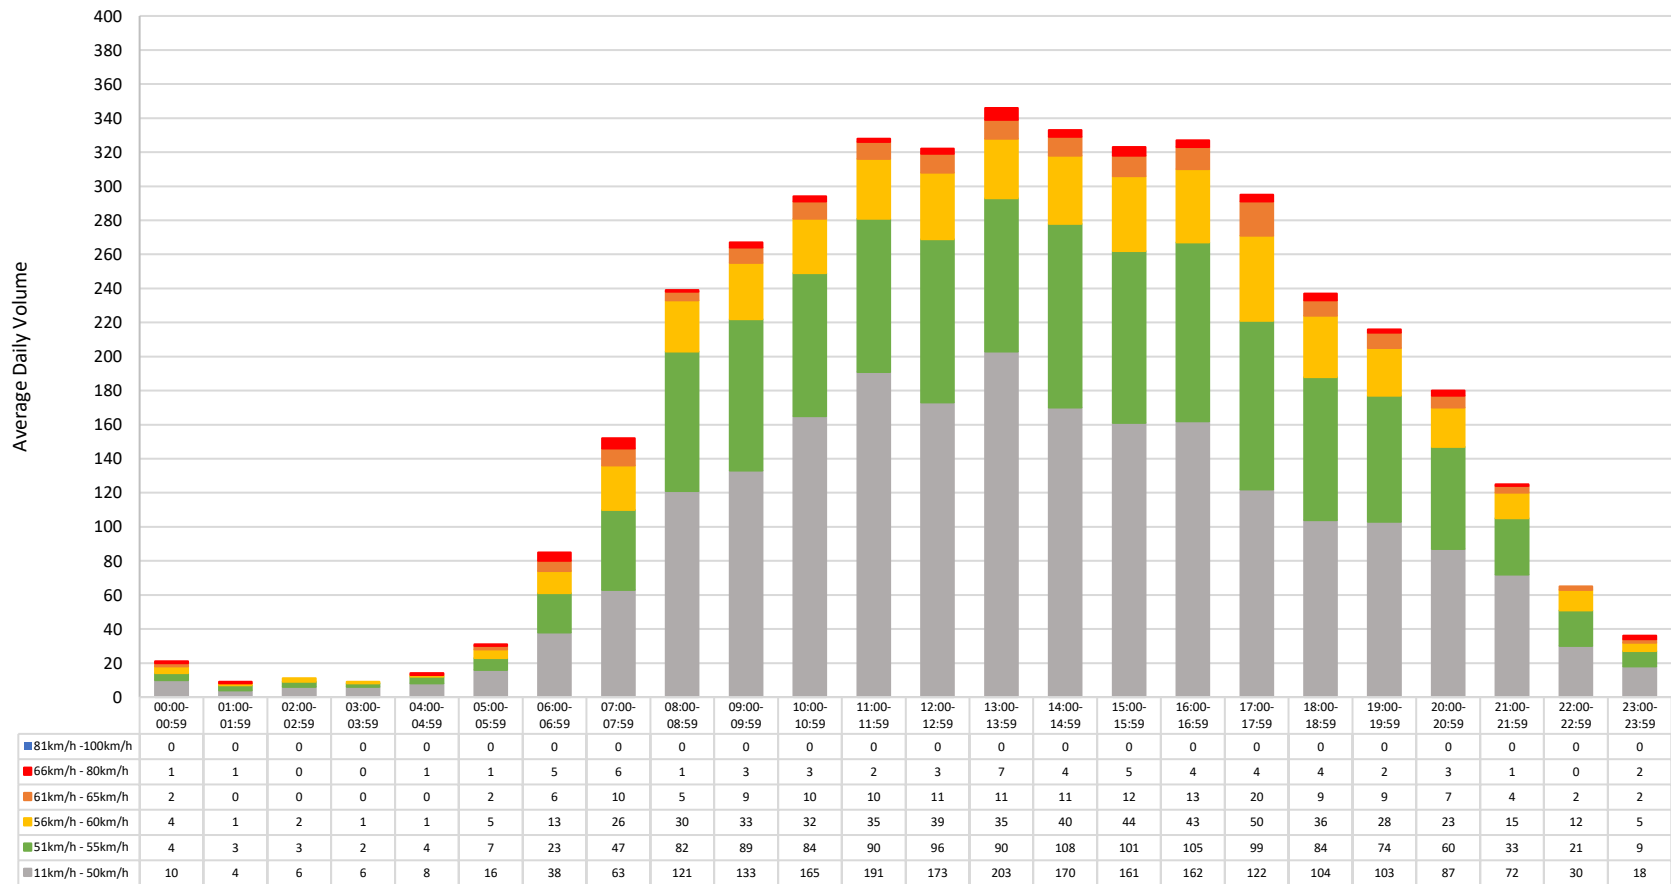
Figure 3- Speed by Hour Analysis for Eastbound Weekdays

Figure 3 above is the speed by hour graph used to determine the time where most speeding occurs on weekdays. The data shows that speeding formed a “u” shape as it increased throughout the day until it reached its peak from 3:00pm to 5:59pm and begins to decline again. There is an additional spike in speeding from 6:00am until 7:59am.

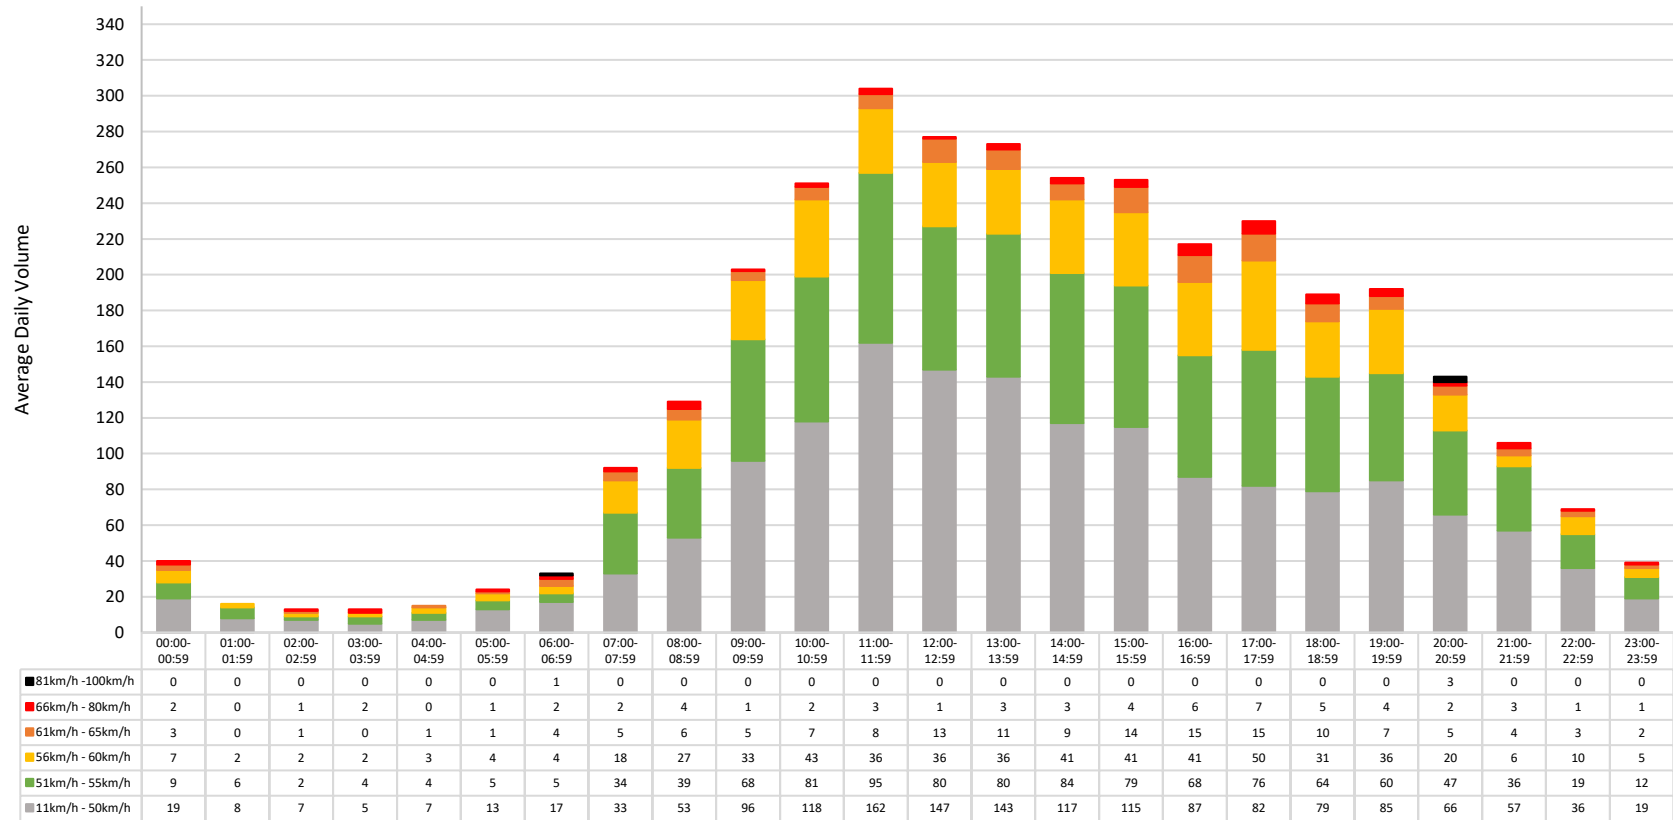
**Figure 4 Speed by Hour Analysis for Eastbound Weekends**

Figure 4 above is the speed by hour graph used to determine the time where most speeding occurs on the weekend. The data shows that speeding was low at night and began to increase around 6:00 am before beginning to decline again at 11:00pm. The speeding reached a peak from 3:00pm until 5:59pm. There was an additional spike in speeding from 8:00am until 8:59am.

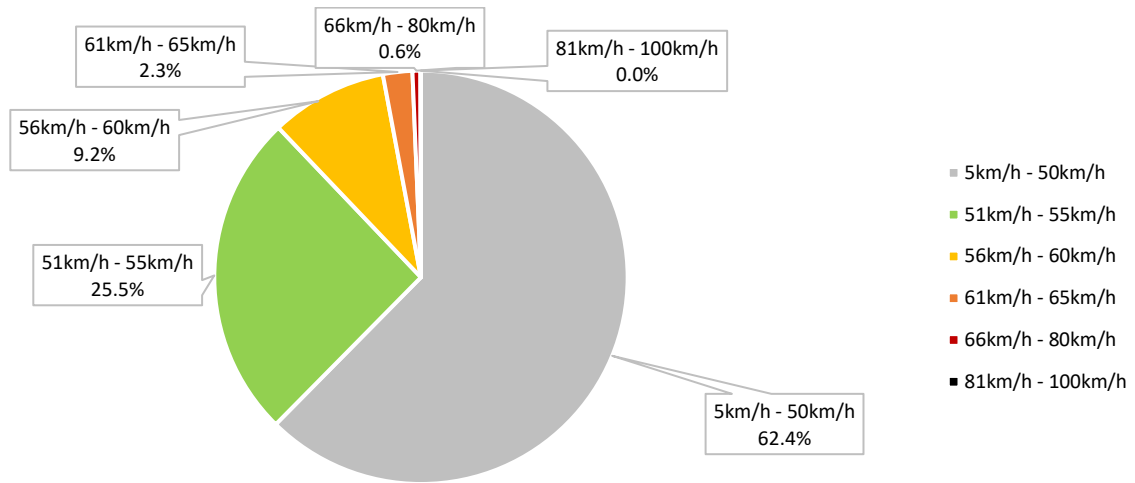
Figure 5- Hugel Avenue Westbound

Figure 5 above shows that 62.4% of vehicles were travelling below the posted speed limit, 34.7% of vehicles were travelling between 51-60 km/h, and 2.9% of vehicles were travelling above 60km/h. Considering the accepted speed limit is 10km/h over the posted speed limit, a total of 97.1% of vehicles were travelling within the accepted speed limit in the westbound direction.

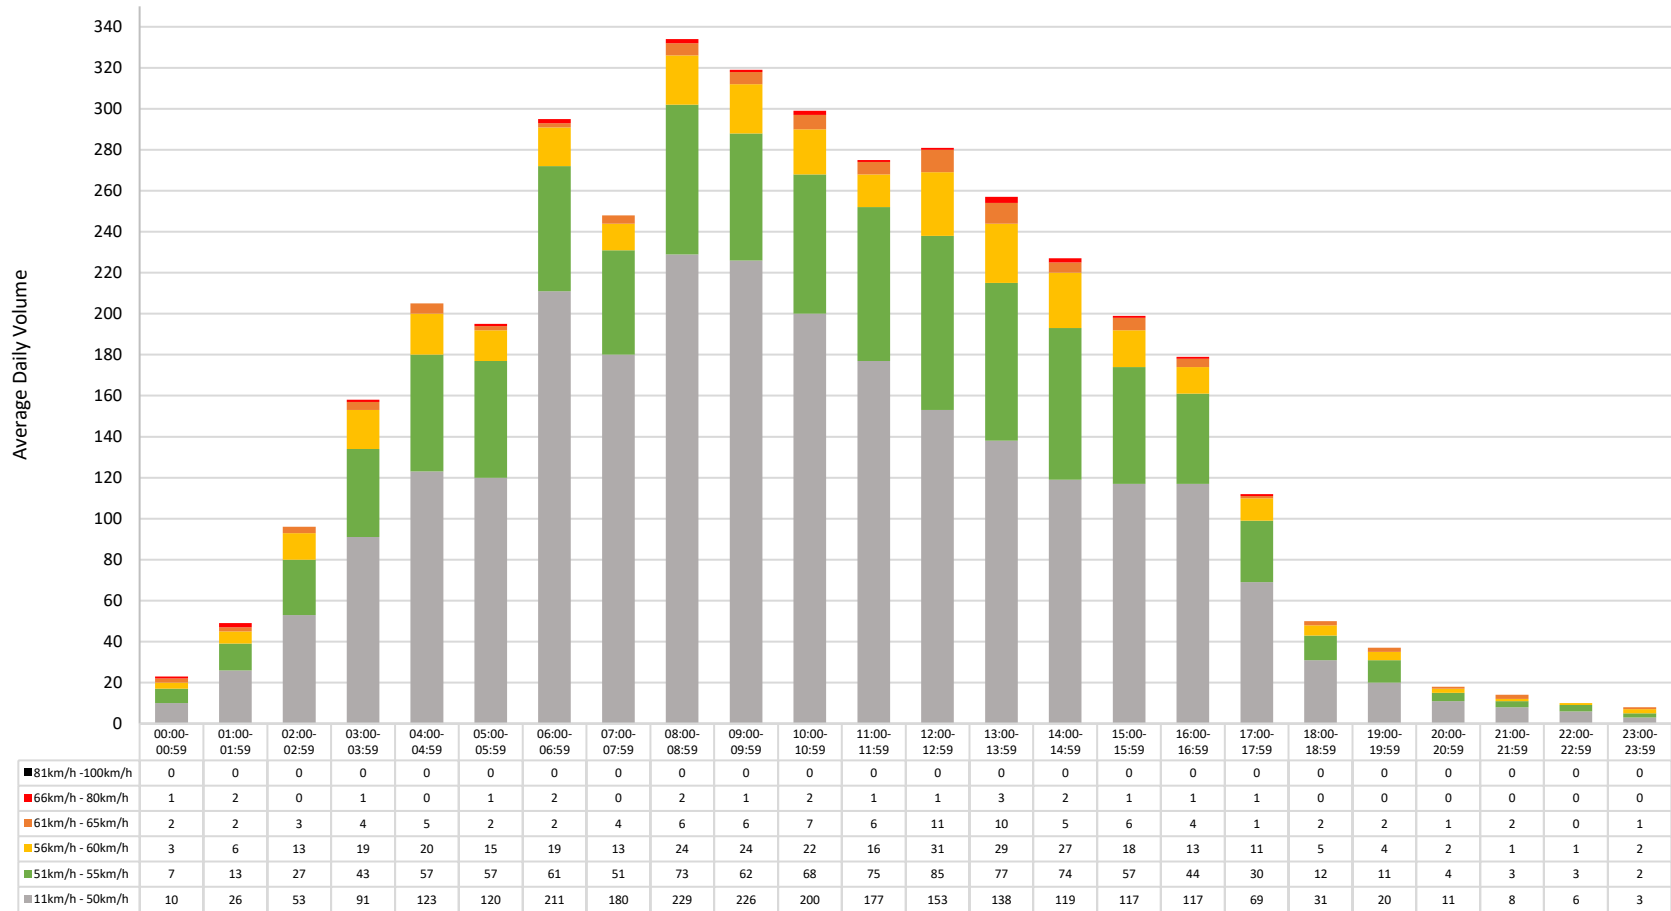
Figure 6- Speed by Hour Analysis for Westbound Weekdays

Figure 6 above is the speed by hour graph used to determine the time where most speeding occurs on weekdays. The data shows that speeding formed a “u” shape as it increased throughout the day until it reached its peak from 8:00am to 10:00pm and begins to decline again. There is an additional spike in speeding from 6:00am until 7:00am.

Figure 6 (weekday) and Figure 7 (weekend) above are the speed by hour graphs used to determine the time where most speeding occurs. The data shows that speeding was relatively consistent in the westbound direction on weekdays and weekends having spikes from 6:00am to 10:00am.

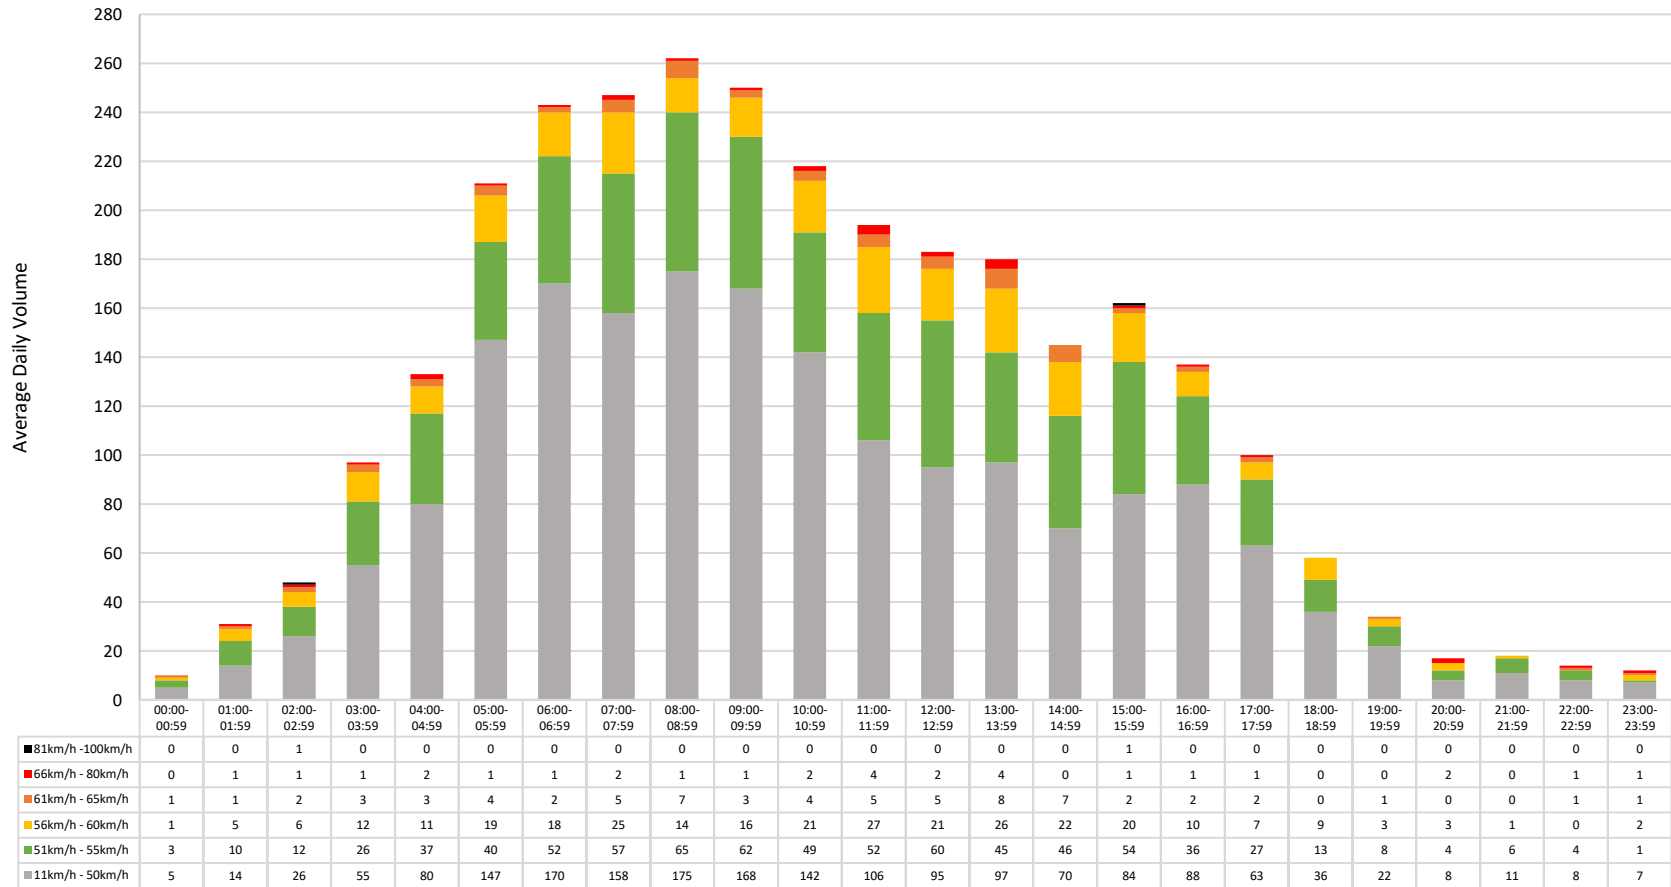
Figure 6- Speed by Hour Analysis for Westbound Weekends

Figure 7 above is the speed by hour graph used to determine the time where most speeding occurs on the weekend. The data shows that speeding was low at night and began to increase around 4:00 am before beginning to decline again at 11:00am. The speeding reached a peak from 7:00am until 10:00am. There was an additional spike in speeding at 3:00pm.

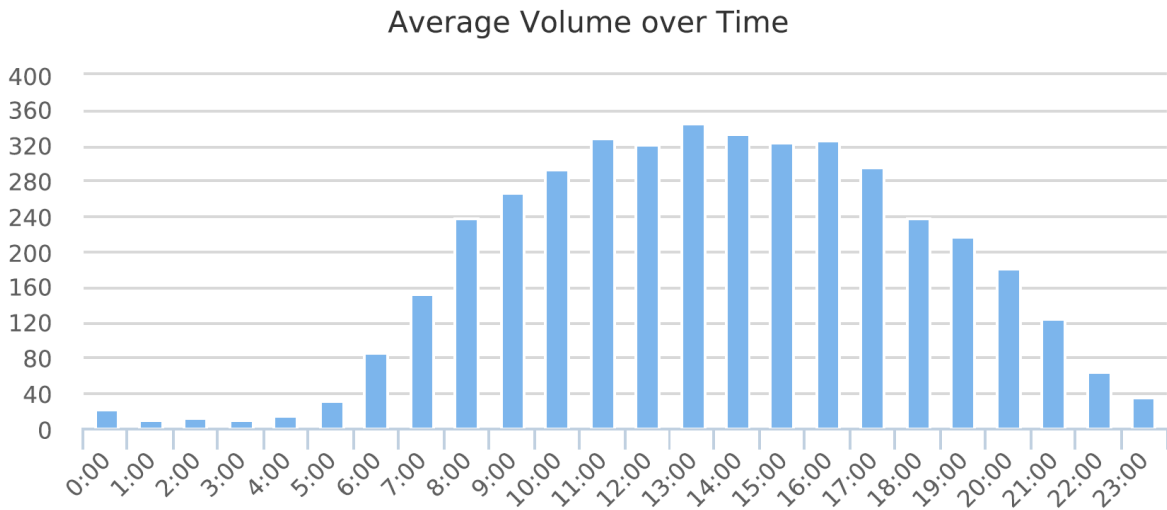
Figure 9 Average Volume per Hour from August 12<sup>th</sup> to August 13<sup>th</sup> and August 16<sup>th</sup> to August 17<sup>th</sup> (Eastbound)

As shown in Figure 10, on weekdays, peak traffic occurs from 1:00pm to 2:59pm in the eastbound direction. Figure 11 shows that on weekends, the peak occurs between 11:00am and 11:59am in the eastbound direction.

The data collected from August 12<sup>th</sup> to August 13<sup>th</sup> and August 16<sup>th</sup> to August 17<sup>th</sup> (weekdays) and August 14<sup>th</sup> to August 15<sup>th</sup> (weekend) are used to analyze the average traffic volume at different times of the day as shown in Figure 10 and Figure 11, respectively.

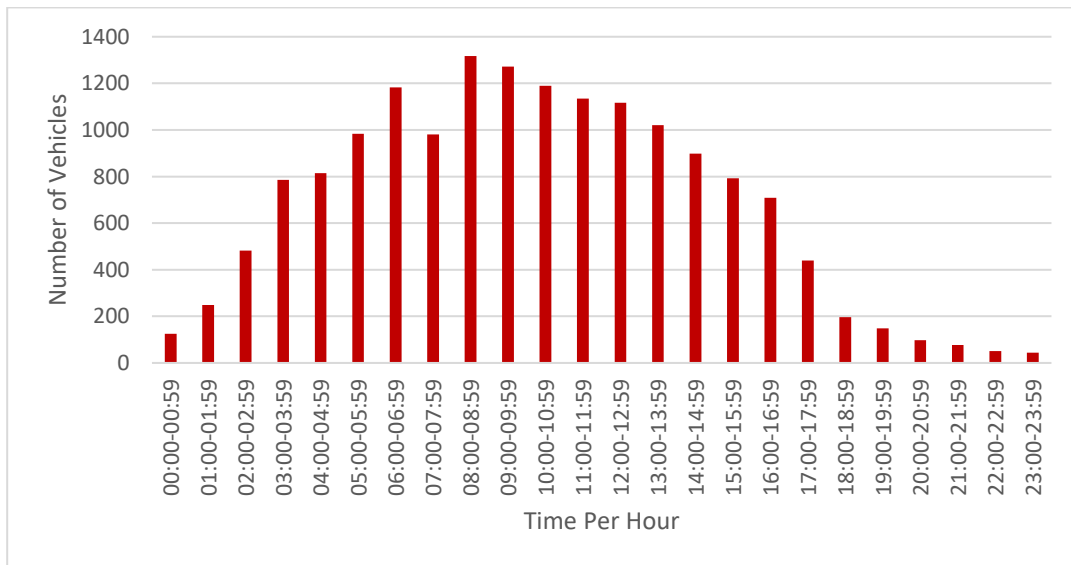
**Figure 11- Average Volume by Hour from August 19<sup>th</sup> to August 20<sup>th</sup> and August 22<sup>nd</sup> to August 25<sup>th</sup>, 2021 (Westbound)**

As shown in Figure 12, peak traffic occurs in the morning from 8:00am to 10:00am on the weekday in the westbound direction. On the weekend shown in Figure 13 a similar pattern was shown, there was a spike from 7:00am to 10:00am.

The data collected from August 19<sup>th</sup> to August 20<sup>th</sup> and August 23<sup>rd</sup> to August 25<sup>th</sup> (weekdays) and August 21<sup>st</sup> and 22<sup>nd</sup> (weekend) are used to analyze the average traffic volume at different times of the day as shown in Figure 12 and Figure 13, respectively.
