Traffic Data Analysis

Midland Point Road
Eastbound and Westbound

Town of Midland
Engineering Department

September 7, 2021

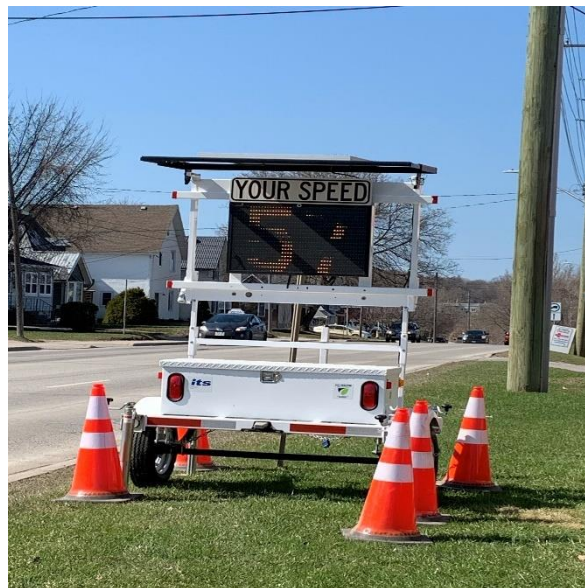
Figure 1- Traffic Trailer

The traffic trailer used was model ATS-3 as shown in Figure 1. The traffic trailer is set to not show the speed as the display was turned off for the duration of this location. The data is collected and grouped into one-hour intervals.

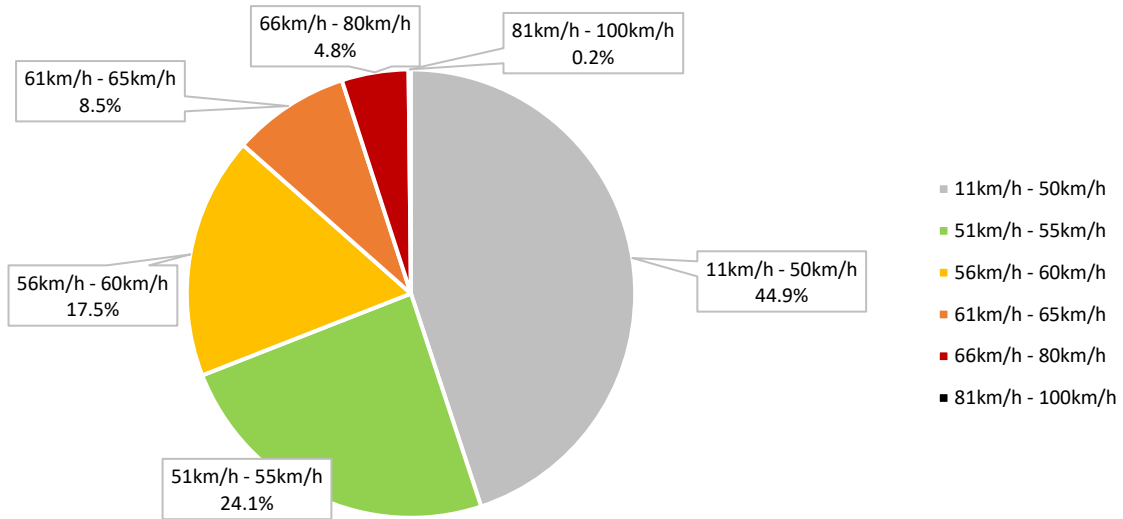
Figure 2- Midland Point Road Eastbound

Figure 2 above shows that 44.9% of vehicles were travelling below the posted speed limit, 41.6% of vehicles were travelling between 51-60 km/h, and 13.5% of vehicles were travelling above 60km/h. Considering the accepted speed limit is 10km/h over the posted speed limit, a total of 86.5% of vehicles were travelling within the accepted speed limit in the eastbound direction.

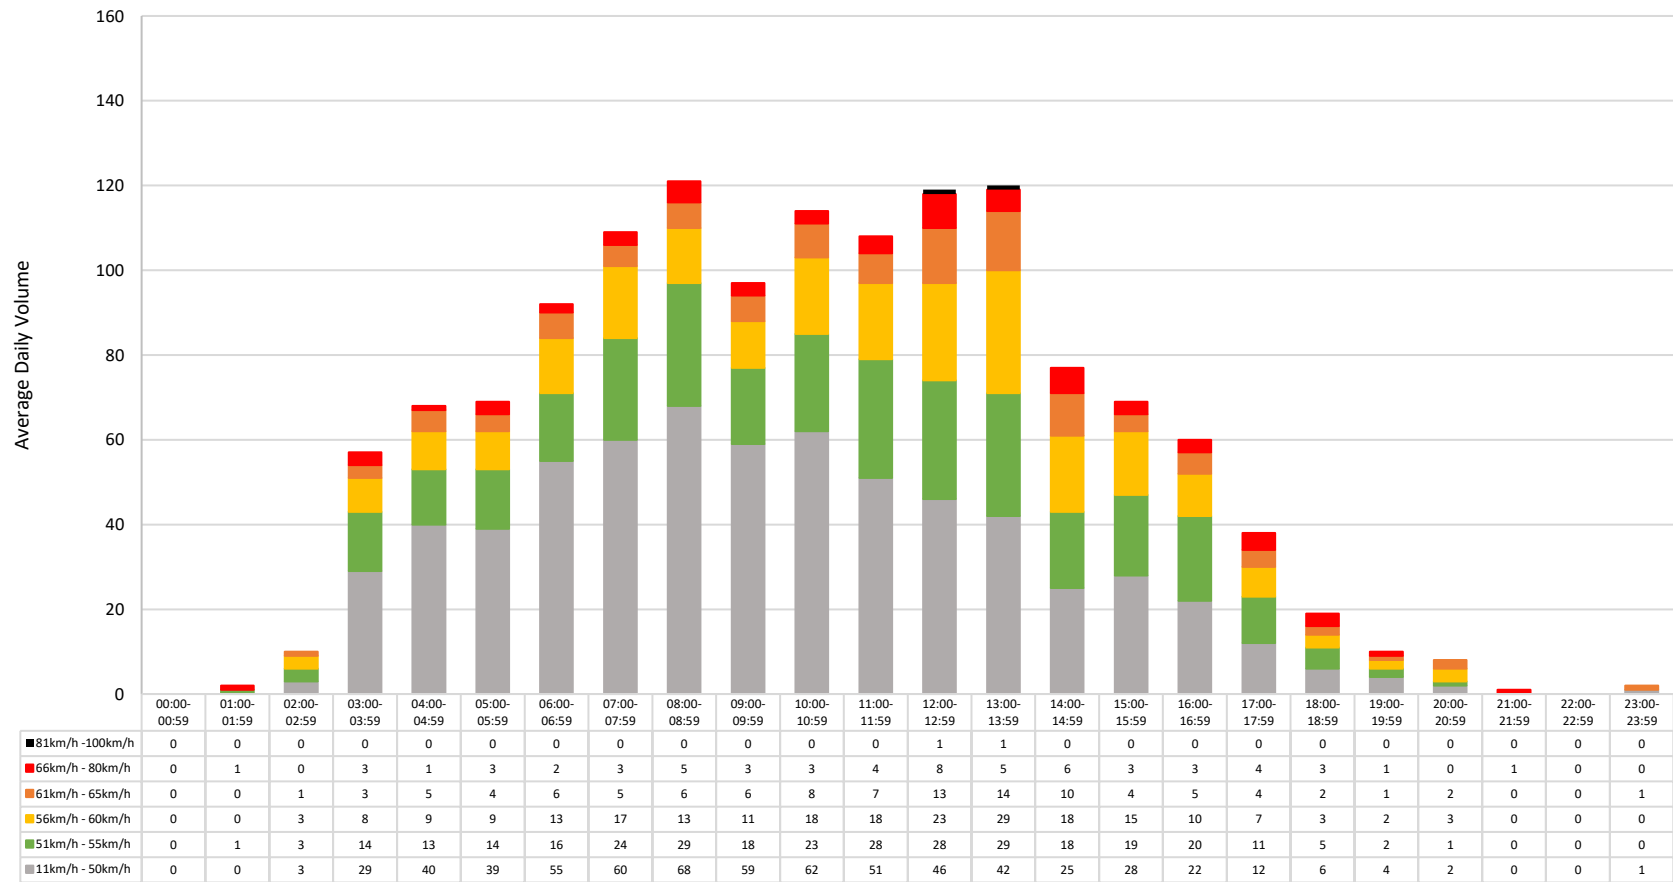
Figure 3- Speed by Hour Analysis for Eastbound Weekdays

Figure 3 above is the speed by hour graph used to determine the time where most speeding occurs on weekdays. The data shows that speeding formed a “u” shape as it increased in the morning and declined throughout the afternoon. It reached its peak from 8:00am to 1:00pm and begins to decline again.

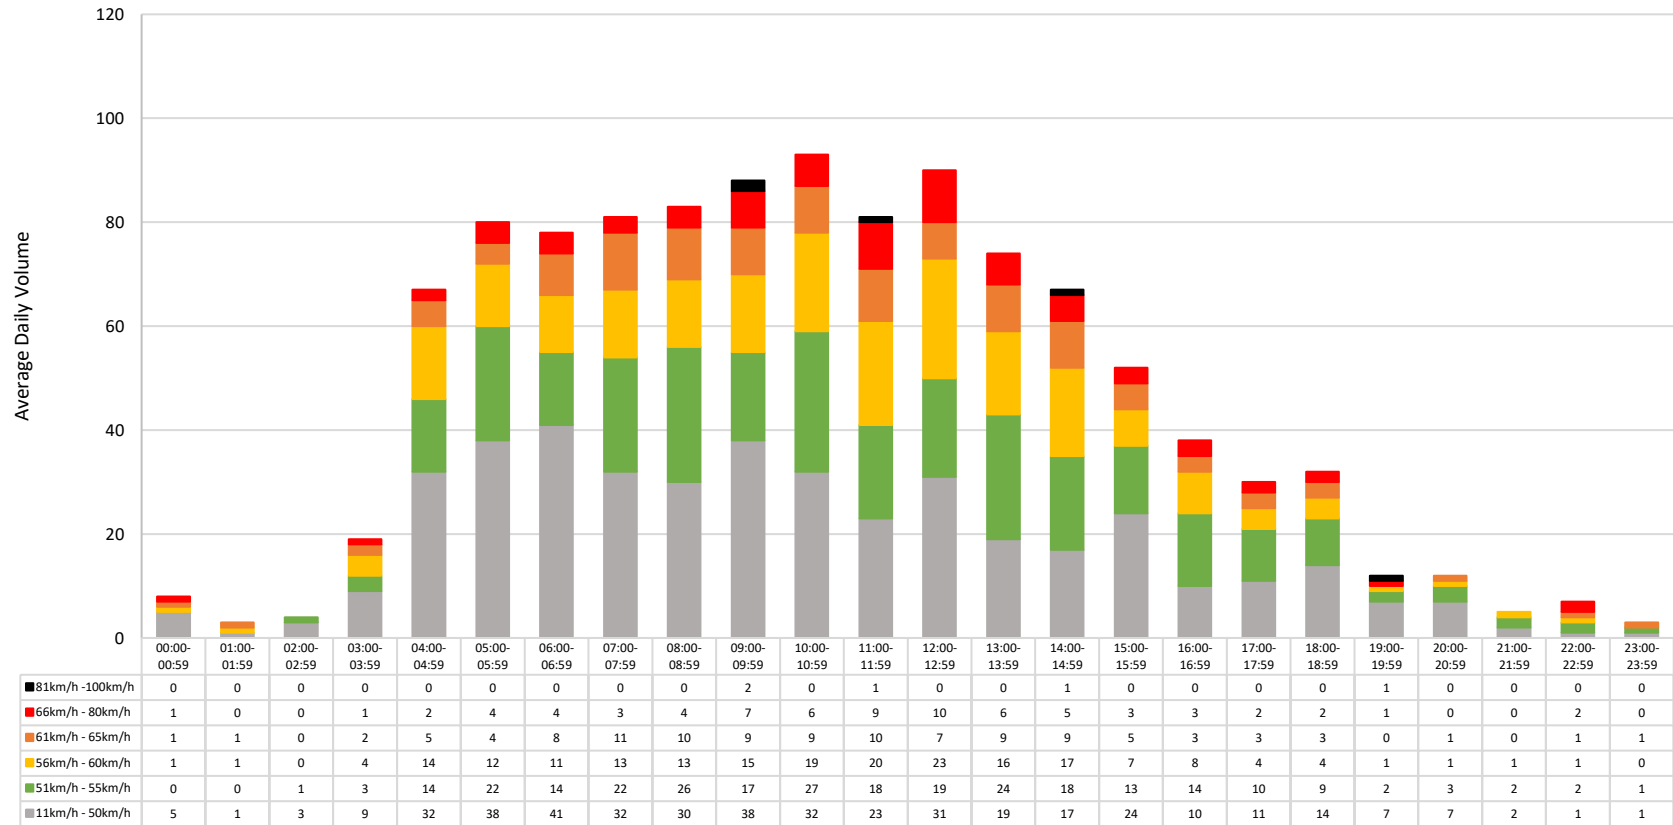
Figure 4 Speed by Hour Analysis for Eastbound Weekends

Figure 4 above is the speed by hour graph used to determine the time where most speeding occurs on the weekend. The data shows that speeding was low at night and began to increase around 4:00 am before beginning to decline again at 1:00pm. The speeding reached a peak from 10:00am until 12:00pm.

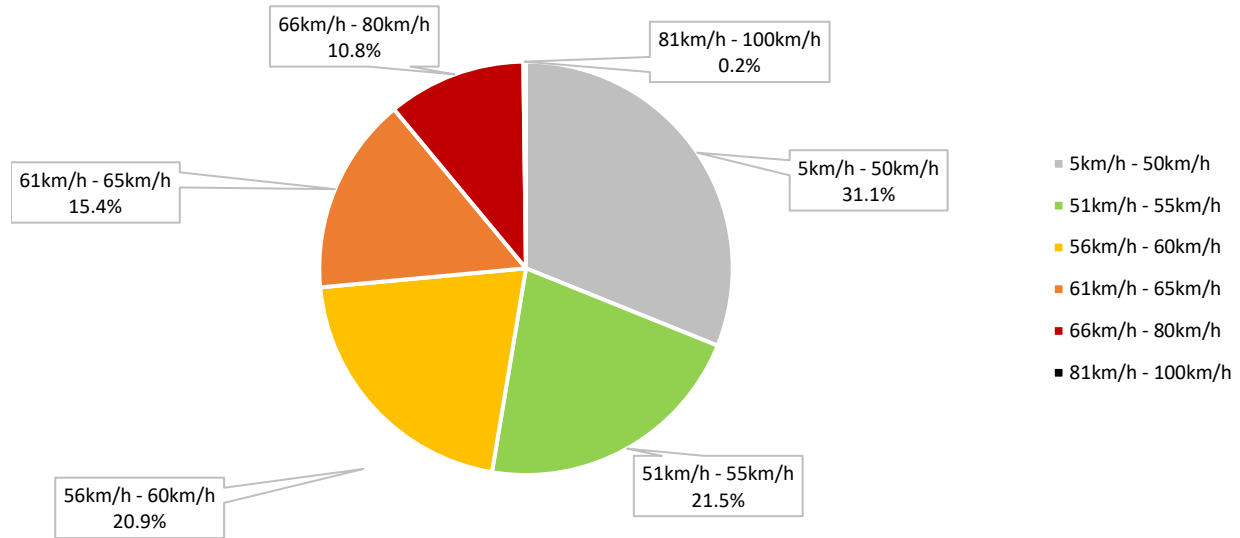
Figure 5- Midland Point Road Westbound

Figure 5 above shows that 31.1% of vehicles were travelling below the posted speed limit, 42.4% of vehicles were travelling between 51-60 km/h, and 26.2% of vehicles were travelling above 60km/h. Considering the accepted speed limit is 10km/h over the posted speed limit, a total of 73.5% of vehicles were travelling within the accepted speed limit in the westbound direction.

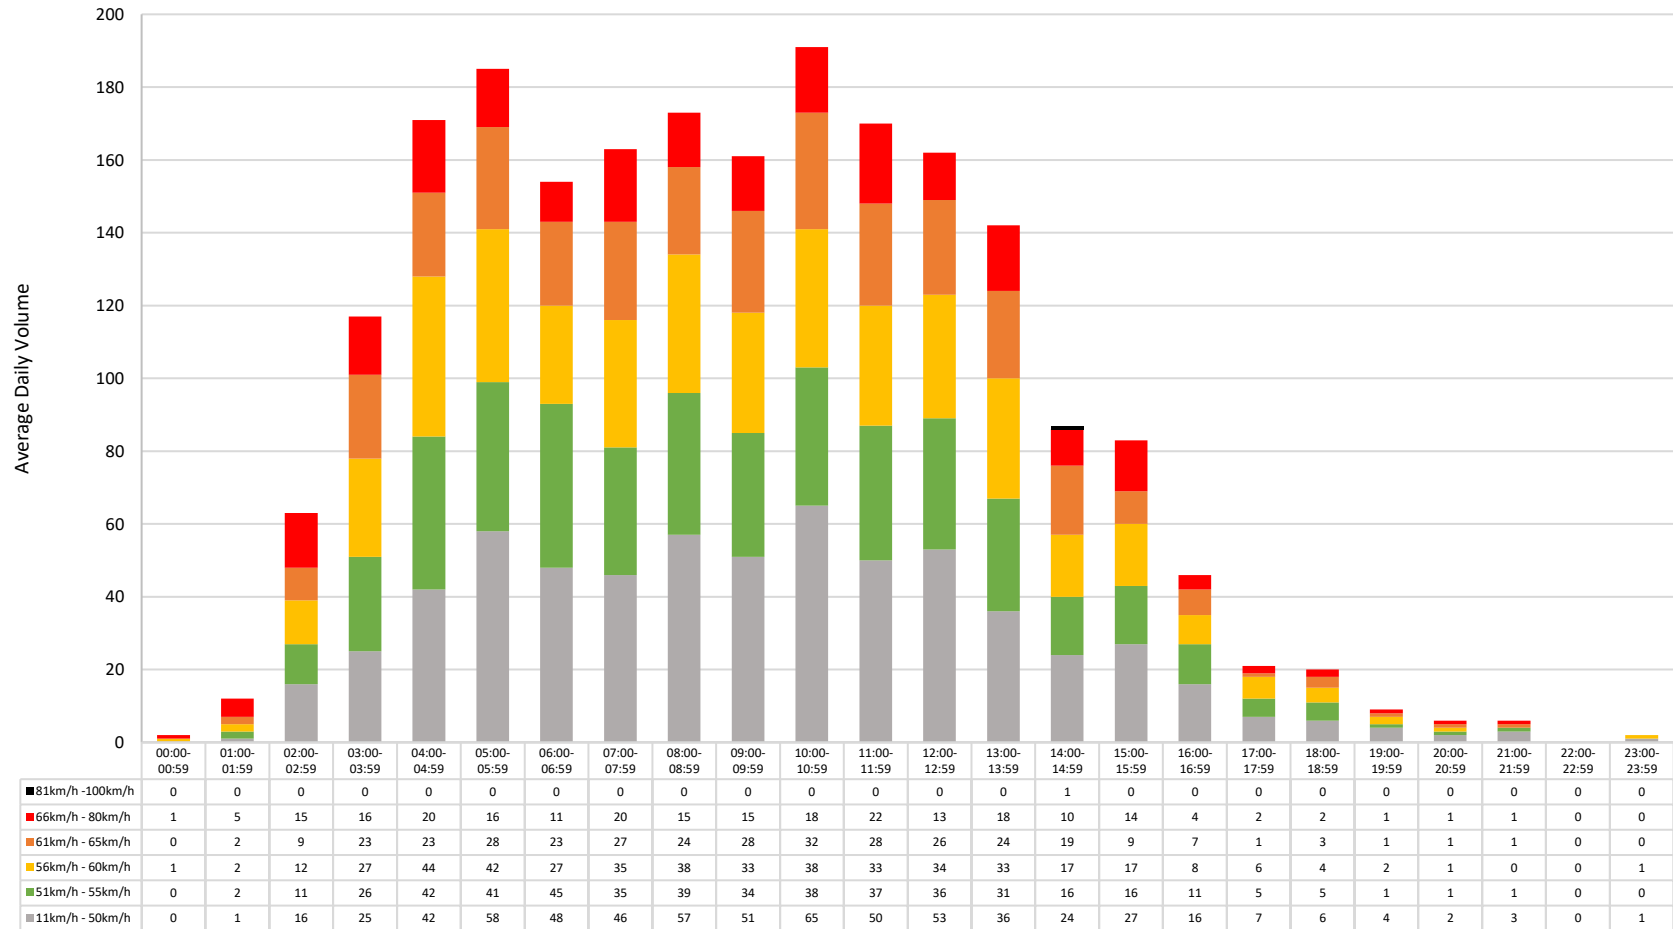
Figure 6- Speed by Hour Analysis for Westbound Weekdays

Figure 6 above is the speed by hour graph used to determine the time where most speeding occurs on weekdays. The data shows that speeding formed a “u” shape as it increased throughout the day until it reached its peak from 10:00am to 12:00am and begins to decline again. There is an additional spike in speeding from 4:00am until 6:00am.

Figure 6 (weekday) and Figure 7 (weekend) above are the speed by hour graphs used to determine the time where most speeding occurs. The data shows that speeding was relatively consistent in the westbound and eastbound direction on weekdays and weekends having spikes from 6:00am to 10:00am.

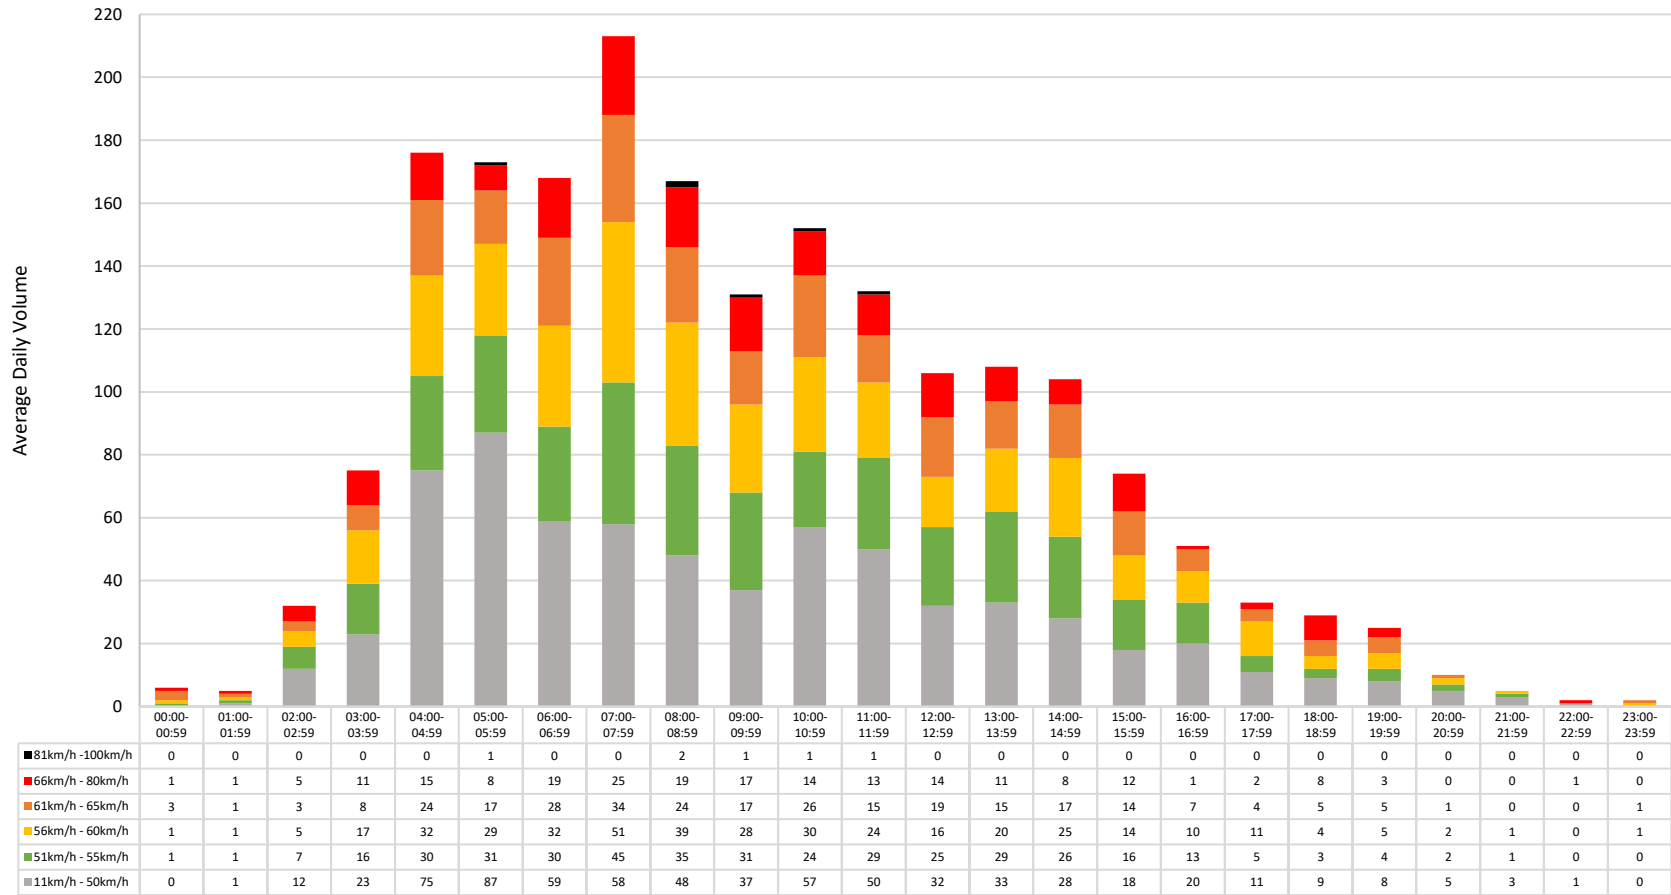
Figure 6- Speed by Hour Analysis for Westbound Weekends

Figure 7 above is the speed by hour graph used to determine the time where most speeding occurs on the weekend. The data shows that speeding was low at night and began to increase around 4:00 am before beginning to decline again at 11:00am. The speeding reached a peak from 7:00am until 8:00am.

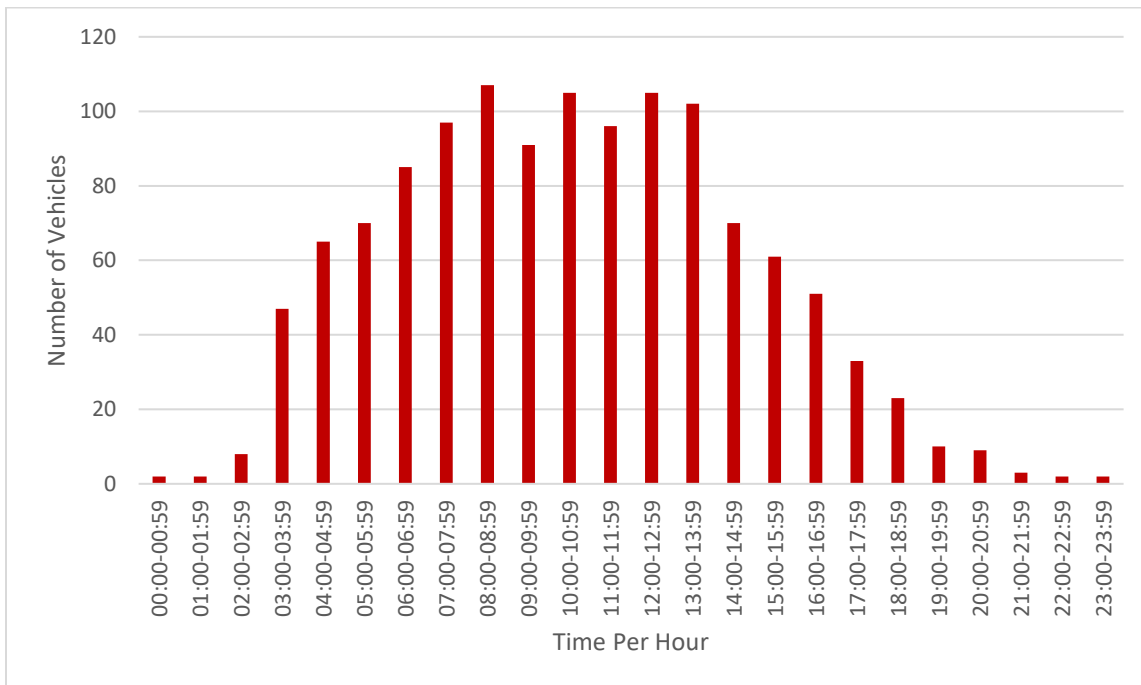
Figure 9 Average Volume per Hour from August 26th to August 27th and August 30th to August 31st (Eastbound)

The data collected from August 26th to August 27th and August 30th to August 31st (weekdays) and August 28th to August 29th (weekend) are used to analyze the average traffic volume at different times of the day as shown in Figure 10 and Figure 11, respectively.

As shown in Figure 10, on weekdays, peak traffic occurs from 8:00am to 1:00pm in the eastbound direction. Figure 11 shows that on weekends, the peak occurs between 10:00am and 12:00pm in the eastbound direction.

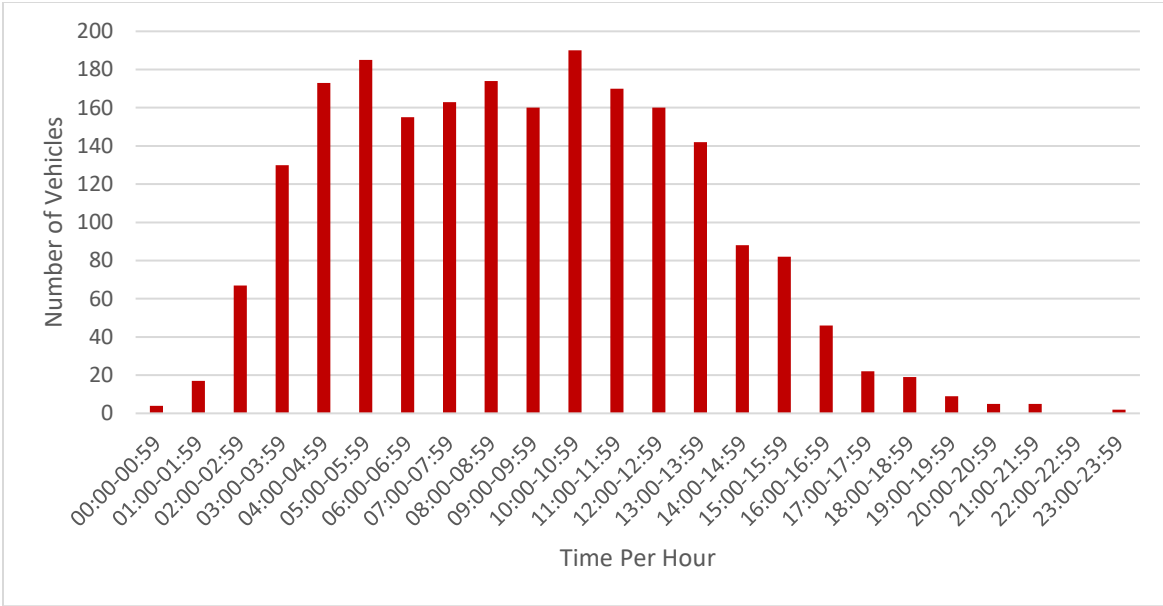
Figure 11- Average Volume by Hour from September 2nd, 3rd, 6th and 7th (Westbound)

The data collected from September 2nd, 3rd, 6th and 7th (weekdays) and September 4th and 5th (weekend) are used to analyze the average traffic volume at different times of the day as shown in Figure 12 and Figure 13, respectively.

As shown in Figure 12, peak traffic occurs in the morning from 5:00am to 10:00am on the weekday in the westbound direction. On the weekend shown in Figure 13 a similar pattern was shown, there was a spike from 7:00am.
