# Traffic Data Analysis

Harbourview Dr

Town of Midland
Engineering Department
July 13<sup>th</sup>, 2023

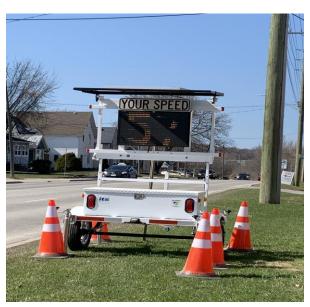
Figure 1 - Traffic Trailer

The traffic trailer used was model ATS-3 as shown in Figure 1. The traffic trailer is set to show the speed of the approaching vehicle and display short messages depending on the speed. The data is collected and grouped into one-hour intervals.
